DEPARTMENT OF TRANSPORTATION

Contract #: 04-0120F4Cty: SF/ALA Rte: 80 PM: 13.2/13.9File #: 69.28**WELDING INSPECTION REPORT****Resident Engineer:**Pursell, Gary**Address:** 333 Burma Road**City:** Oakland, CA 94607**Report No:** WIR-006200**Date Inspected:** 12-Apr-2009**Project Name:** SAS Superstructure**OSM Arrival Time:** 700**Prime Contractor:** American Bridge/Fluor Enterprises, a JV**OSM Departure Time:** 1900**Contractor:** Zhenhua Port Machinery Company, Ltd (ZPMC), Changxing Island **Location:** Shanghai, China**CWI Name:** Shi Lin**CWI Present:** Yes No**Inspected CWI report:** Yes No N/A**Rod Oven in Use:** Yes No N/A**Electrode to specification:** Yes No N/A**Weld Procedures Followed:** Yes No N/A**Qualified Welders:** Yes No N/A**Verified Joint Fit-up:** Yes No N/A**Approved Drawings:** Yes No N/A**Approved WPS:** Yes No N/A**Delayed / Cancelled:** Yes No N/A**Bridge No:** 34-0006**Component:** OBG segments**Summary of Items Observed:**

WELDING INSPECTION REPORT

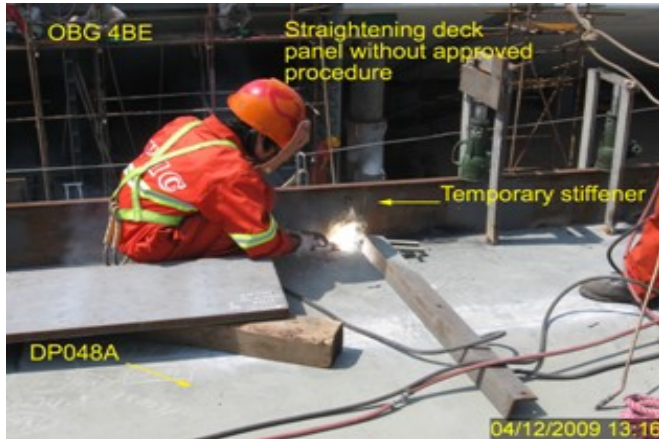
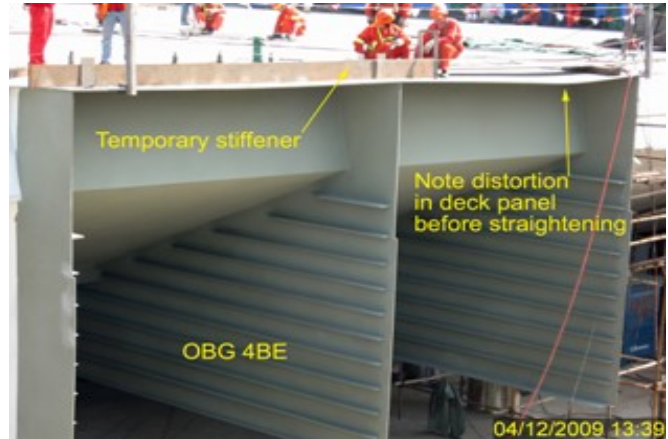
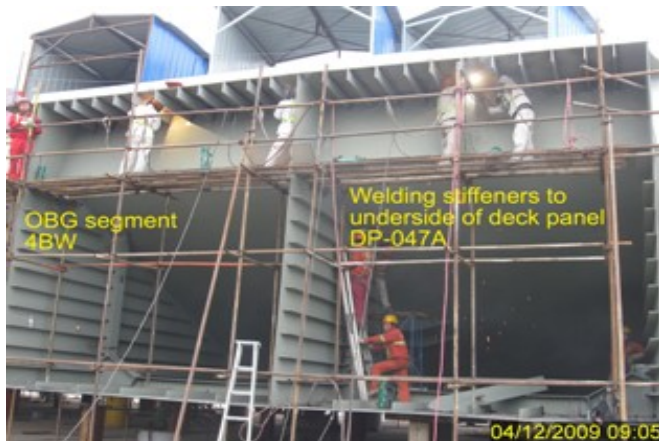
This QA observed that the contractor has performed material straightening without an approved straightening

procedure. The contractor has attempted to straighten the deck plate on OBG segment by tack welding temporary stiffeners to the top side of the deck plates in the area of the crossbeams. The OBG segment and deck plate is identified as OBG segment 4BE deck panel DP047A. AWS D1.5 2002 section 3.1.5 prohibits welding on the material if no weld is detailed on the drawings and 3.7.3 requires engineers approval prior to straightening material distorted by welding. This QA notified ZPMC QA identified as Mr. Fu Yuhong and ABF QA inspector identified as Mr. Kevin Chen that an incident report would be forth coming concerning this issue.
